MANAGING THE SAFETY CHALLENGES IN COMMISSIONING AND OPERATION OF LARGE SCALE RO SEAWATER DESALINATION PLANTS

Authors: *Sean Anthony McCagh, Scott Murphy, Tom Pankratz, Steve Pickering, Mark Thompson.*

Abstract

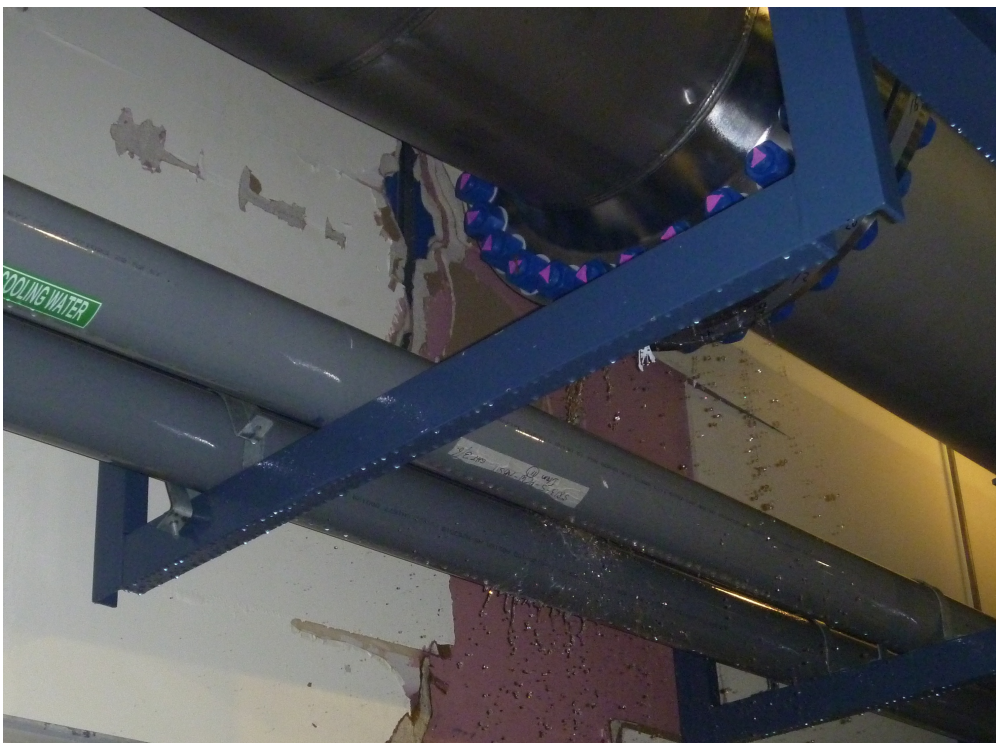
High pressure release from a flanged joint occurred due to flange misalignment, and in another case due to a breakdown of the permit to work system. In each case, the failures resulted in significant damage to surrounding structures, illustrating the potentially catastrophic consequence had personnel been in the vicinity at the time. These events served as a reminder that even when highly qualified personnel carry out works, vigilance is still required via clear procedures, regular training, and third party checks to ensure required standards are being met.

Figure 1: Damage to building due to high pressure flange failure

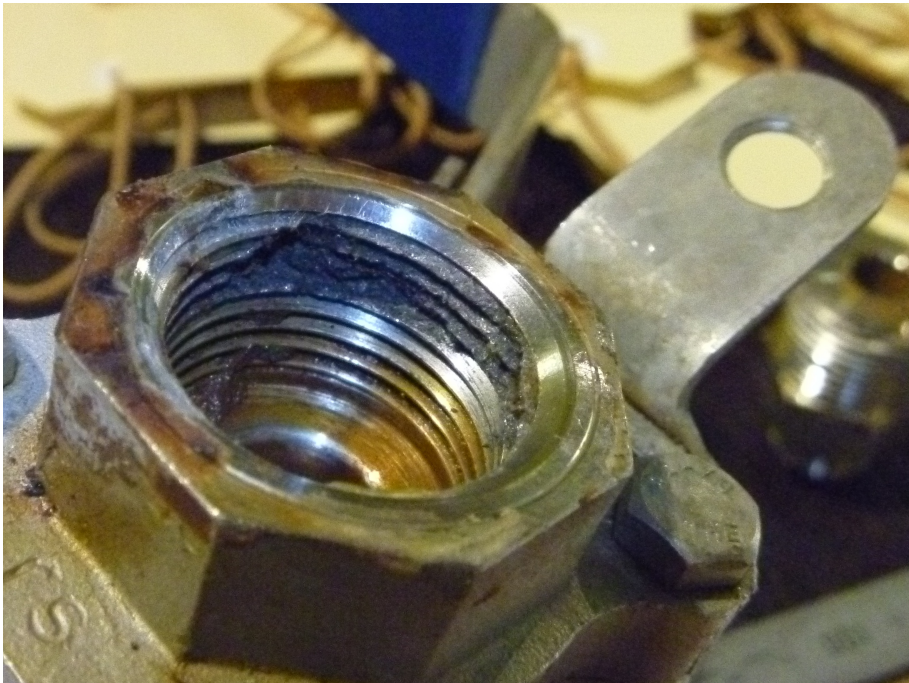
3.3.3 *Threaded Joint Corrosion* – During early operation (August 2011) widespread threaded joint corrosion was discovered across the RO process areas. A small leak on a drain valve was the first indication. Further investigation found a number of threaded connections with corrosion, primarily manifold drains and in pump casing drains, but also in various other applications.

Figure 2: Example of corrosion of threaded fittings encountered in RO seawater desalination service

Threaded joints have now been designed out of high pressure areas at GCDP, replaced by flanged, compression and Victaulic style couplings. While the likelihood of a threaded joint catastrophically failing was assessed as low due to the nature of the joint, it was determined that due to the sheer quantity of these joints, the imposition in monitoring and management of the risk was unacceptable to the operation.

Based on GCDP experience, the use of threaded joints in high pressure seawater applications should be avoided due to the crevice corrosion risk, with a corresponding hazard and a consequent high maintenance and monitoring load.
